**DEPARTMENT OF TRANSPORTATION**

Contract #: 04-0120F4Cty: SF/ALA Rte: 80 PM: 13.2/13.9File #: 1.28**WELDING INSPECTION REPORT****Resident Engineer:** Siegenthaler, Peter**Address:** 333 Burma Road**City:** Oakland, CA 94607**Report No:** WIR-017363**Date Inspected:** 11-Oct-2010**Project Name:** SAS Superstructure**OSM Arrival Time:** 630**Prime Contractor:** American Bridge/Fluor Enterprises, a JV**OSM Departure Time:** 1500**Contractor:** American Bridge/Fluor Enterprises, a JV**Location:** Job Site**CWI Name:** See below**CWI Present:** Yes No**Inspected CWI report:** Yes No N/A**Rod Oven in Use:** Yes No N/A**Electrode to specification:** Yes No N/A**Weld Procedures Followed:** Yes No N/A**Qualified Welders:** Yes No N/A**Verified Joint Fit-up:** Yes No N/A**Approved Drawings:** Yes No N/A**Approved WPS:** Yes No N/A**Delayed / Cancelled:** Yes No N/A**Bridge No:** 34-0006**Component:** SAS OBG**Summary of Items Observed:**

**2E-pp13.5-E2-SW Access Hole Restoration**

**7W/8W-A1-A5**

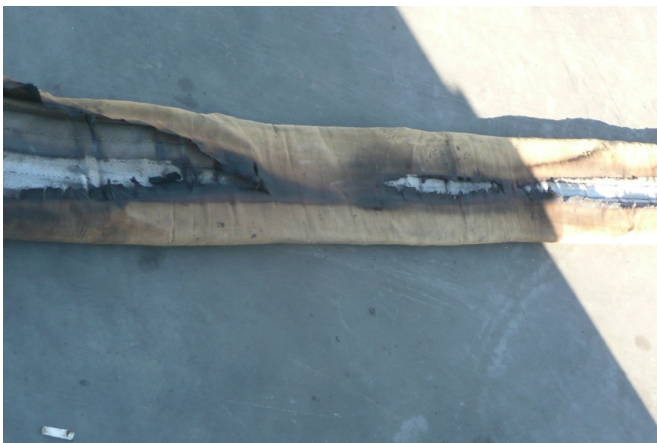
In addition to the dimensional verification the QA Inspector randomly observed an area of the transverse weld joint approximately 400mm in length that appeared to be distorted or warped. The QA Inspector randomly observed the ABF Welding Superintendent Dan Ieraci removing the induction heating blanket. Mr. Ieraci informed the QA Inspector the blanket must have malfunctioned (see summary of conversation). The QA Inspector determined the top deck plate was approximately 375°F at the time of the QA Inspectors arrival. The QA Inspector measured the temperature with SE QC Inspector calibrated temperature indicating laser. The QA Inspector randomly performed dimensional measurements of the distorted area and noted it appeared to deflect approximately 8-9mm. The QA Inspector observed the inorganic zinc coating on the deck plate appeared to had been burned due to excessive heat. In addition the QA Inspector observed the induction heating blanket and noted it also appeared to had been burned up and or destroyed (pictured below).

Mr. Ieraci informed the QA Inspector the induction heating blanket must have overheated and malfunctioned. Mr. Ieraci did acknowledge the inorganic zinc coating had been discolored due to excessive heat caused by the malfunctioning heat blanket. The QA Inspector pointed the distorted area of the top deck plate to Mr. Ieraci and he (Ieraci) acknowledged the plate warped or deflected do to excessive localized heating. Mr. Ieraci informed the QA Inspector he was unclear what the temperature of the steel was previously, but assured the QA Inspector the induction heating blankets were not capable of reaching temperatures above 400°F. The QA Inspector noted to Mr. Ieraci the induction heating blanket that was removed from the above identified transverse weld joint appeared to have been burned or actually caught fire and it would only appear the blanket reached temperatures greater than 400°F. Mr. Ieraci reiterated to the QA Inspector the induction heat blankets were not capable of reaching temperatures greater than 400°F.
